# Typological Analysis of Wooden Hypostyle Mosques: The Case of Kemaliye

**Keywords:** wooden hypostyle mosques, wooden columned and wooden ceilinged mosque, mosque typology, Kemaliye, typological analysis

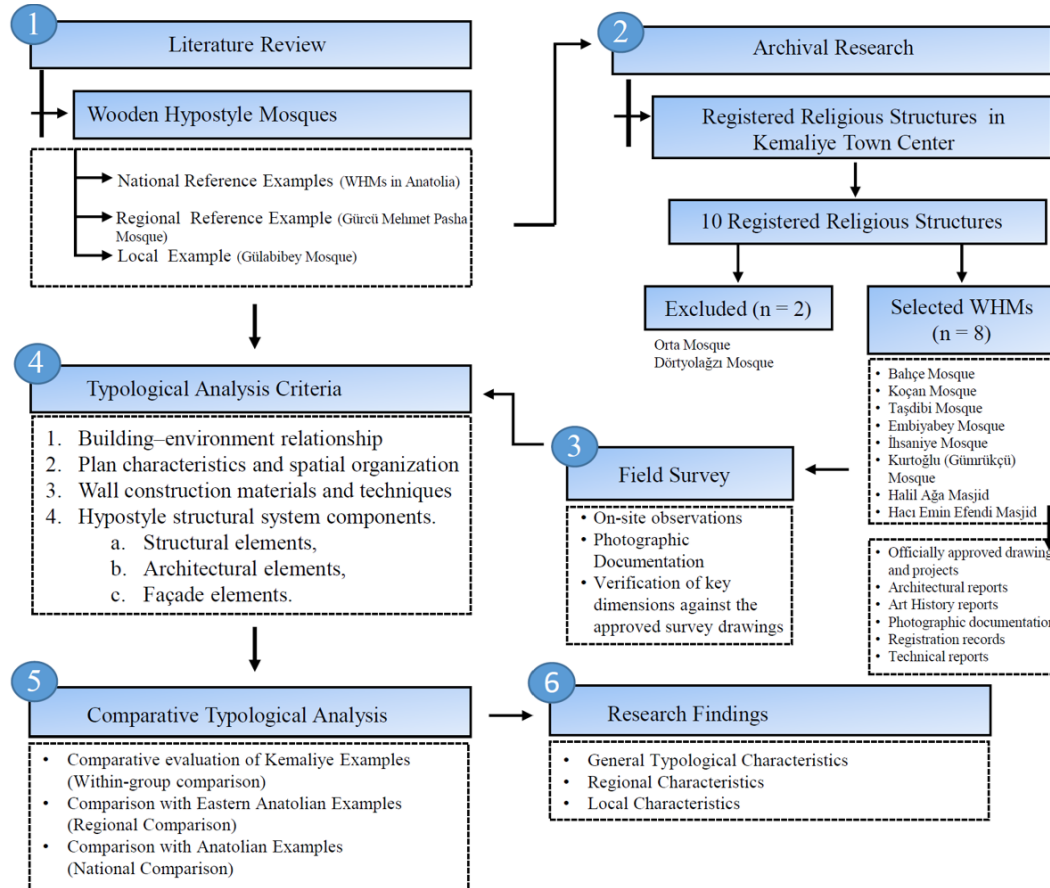
**Figure 7.** Methodological workflow of the typological analysis (by the authors)

The methodological framework of this study consists of six sequential stages: literature review, archival research, field survey, establishment of typological analysis criteria, comparative typological analysis, and interpretation of the findings (Figure 7). The literature review establishes the conceptual and typological background of wooden hypostyle mosques in Anatolia, while the archival research and field survey provide the documentary and empirical data for the analysis. These data are subsequently evaluated through predefined typological criteria, enabling a systematic comparison of the Kemaliye examples with regional and Anatolian wooden hypostyle mosques.

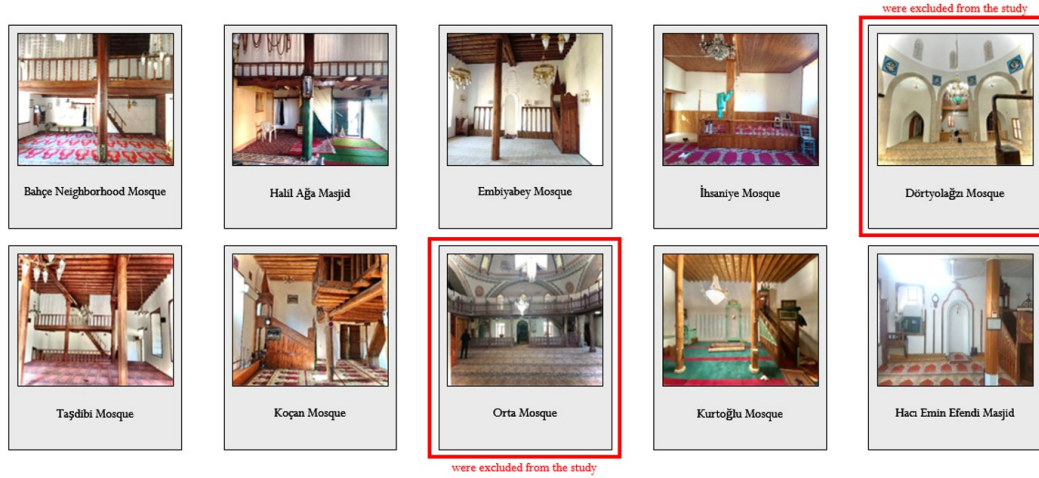
**Figure 8.** The registered religious structures included in and excluded from the scope of the study (by the authors)

Archival investigations revealed that 10 registered religious structures (8 mosques and 2 masjids) are located in Kemaliye's town center. Among these, Orta Mosque and Dört yolağzı Mosque were excluded from the study's scope due to the absence of wooden columns and a wooden ceiling. Consequently, eight structures—namely Bahçe Mosque, Koçan Mosque, Taşdibi Mosque, Embiyabey Mosque, İhsaniye Mosque, Kurtoğlu (Gümrükçü) Mosque, Halil Ağa Masjid, and Hacı Emin Efendi Masjid—were included in the analysis studies (Figure 8). These selected buildings constitute the analytical sample of the study.

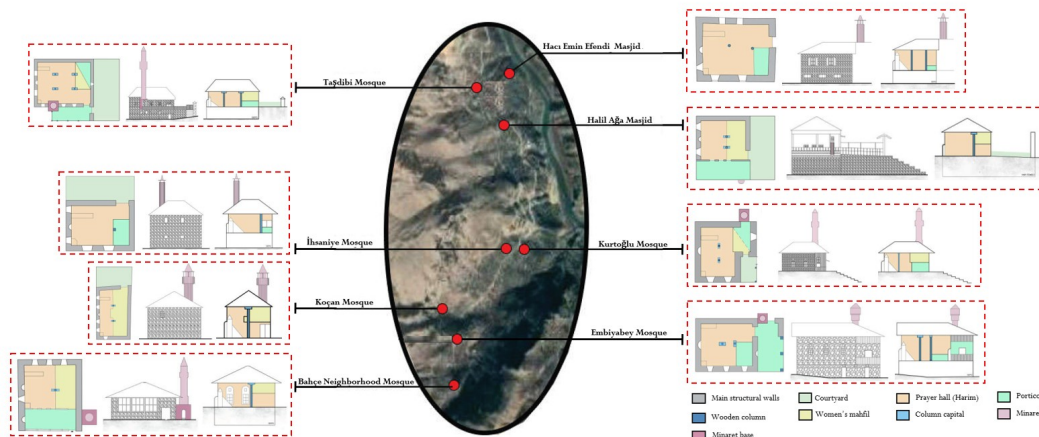
**Figure 9.** Measured drawings of the mosques located in the town center of Kemaliye, including plans, sections, and elevations (by the authors)

In this section, eight registered historical structures in the Kemaliye settlement were examined under four main categories: building–environment relationship; plan characteristics and spatial elements; wall construction materials and techniques; and hypostyle structural system components. The findings obtained from this analysis are systematically presented through visual materials and graphical representations (Figure 9).

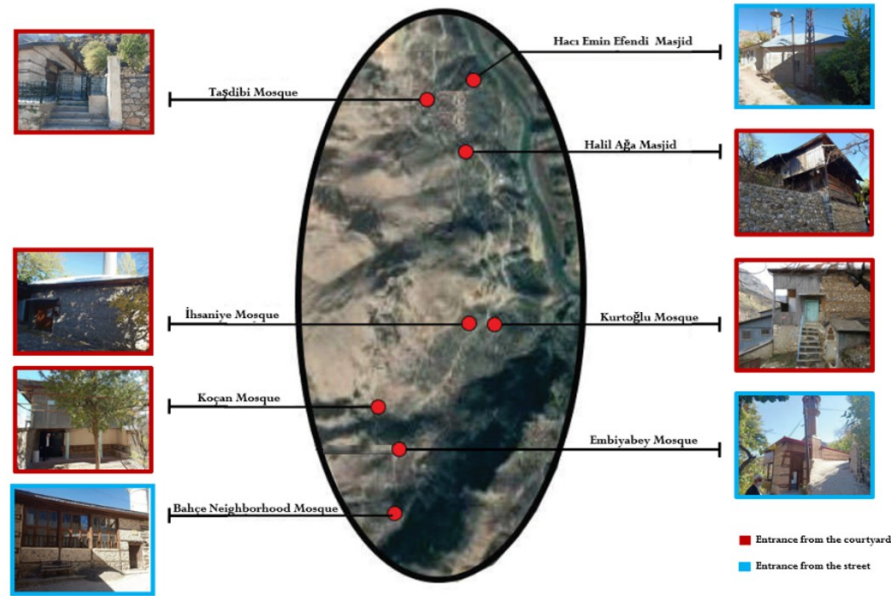
**Figure 10.** Entrance configurations of the mosques (by the authors)

Within the scope of the building–environment relationship, the building's access pattern, number of entrances, entrance orientation, and the surrounding built environment were evaluated. Among the eight registered mosques examined, five (62%) are accessed through a courtyard, whereas three (38%) provide direct street access (Figure 10).

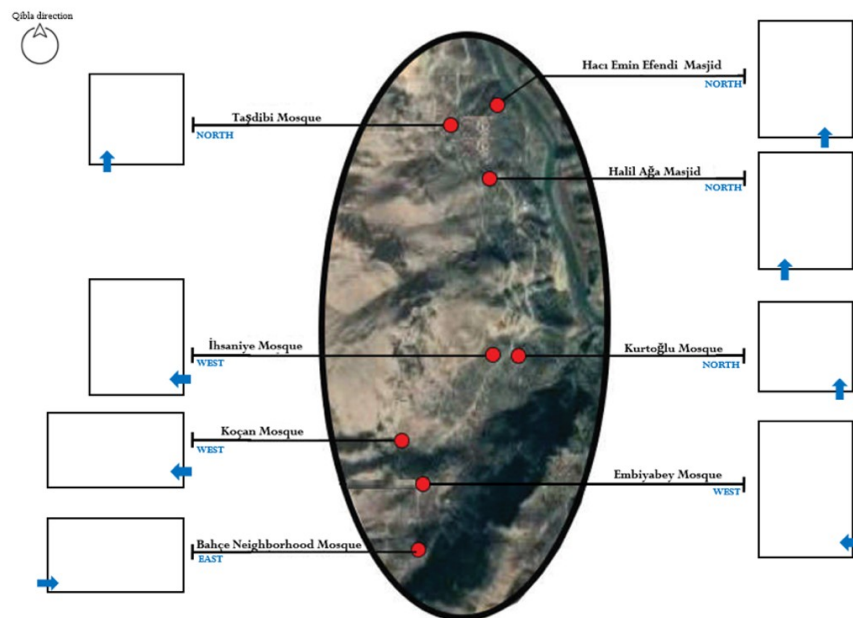
**Figure 11.** Number of entrances and entrance orientations of the mosques (by the authors)

Regarding entrance configuration, all structures had a single entrance (Figure 11). An analysis of entrance orientation indicates that four mosques (50%) are accessed via the north façade, three (38%) via the west, and one (12%) via the east (Figure 11).

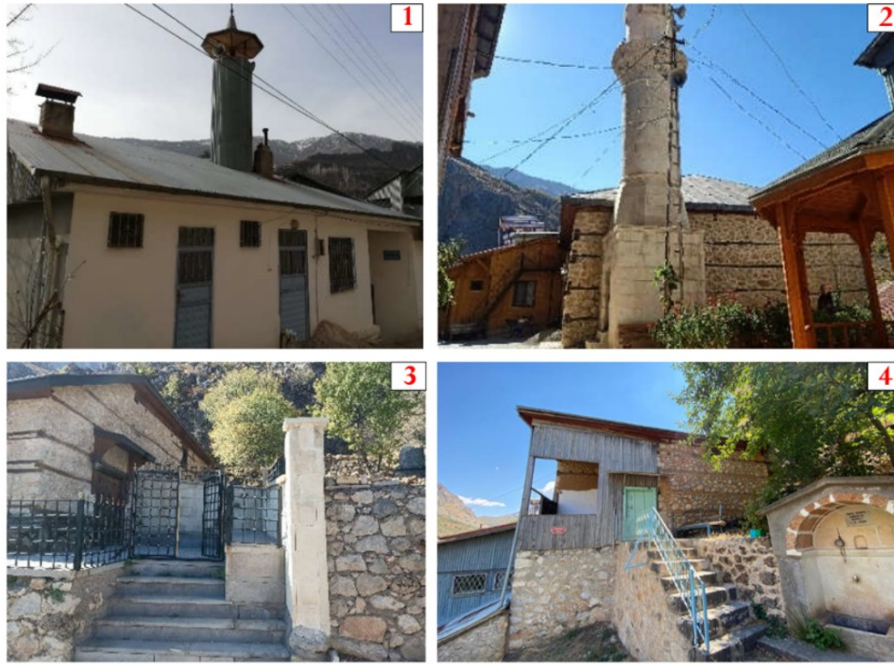
Regarding the environmental context, six of the mosques (75%) are located within a built environment that includes auxiliary structures such as residential units, lodgings, graveyards (*hazire*), and fountains, while two (25%) are situated in relatively open

**Figure 12.** Structures and spatial elements located in the immediate surroundings of the mosques: (1) Lodging unit adjacent to Hacı Emin Efendi Masjid; (2) Built environment surrounding Bahçe Mahallesi Mosque; (3) Entrance area and adjacent *hazire* (graveyard) of Taşdibi Mosque; (4) Fountain and associated structures located around Kurtoğlu Mosque (by the authors)

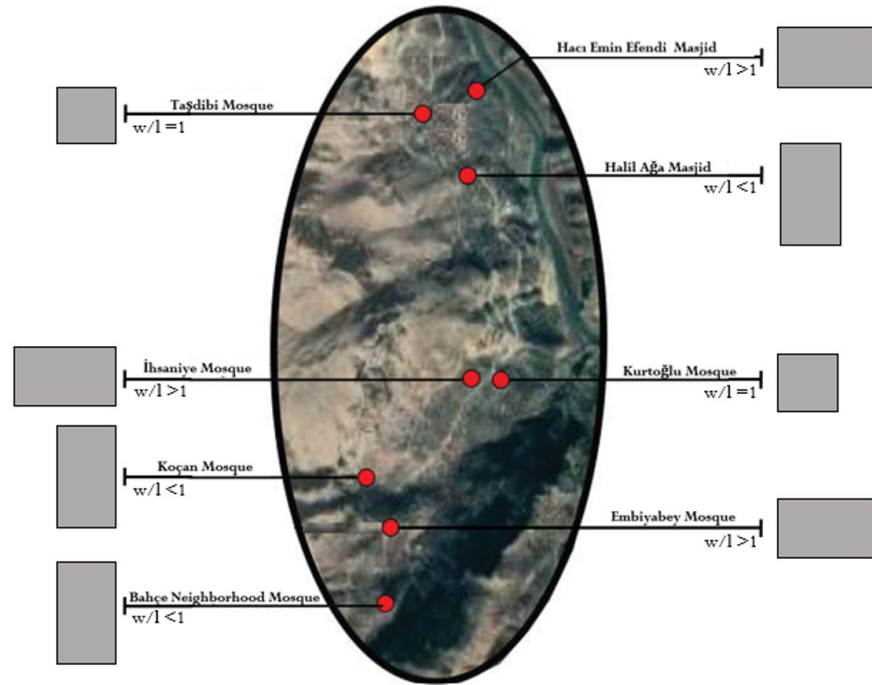
Figure 13. Mosque plan forms (by the authors)

An examination of mosque plan forms reveals that three structures (37.5%) have a  $w/l > 1$  ratio, three (37.5%) have a  $w/l < 1$  ratio, and two (25%) have a  $w/l = 1$  ratio (Figure 13). When the plan forms of the *harim* are considered, four structures (50%) have a  $w/l > 1$  ratio, while two (25%) have a  $w/l < 1$  ratio and two (25%) exhibit a  $w/l = 1$  ratio (Figure 14).

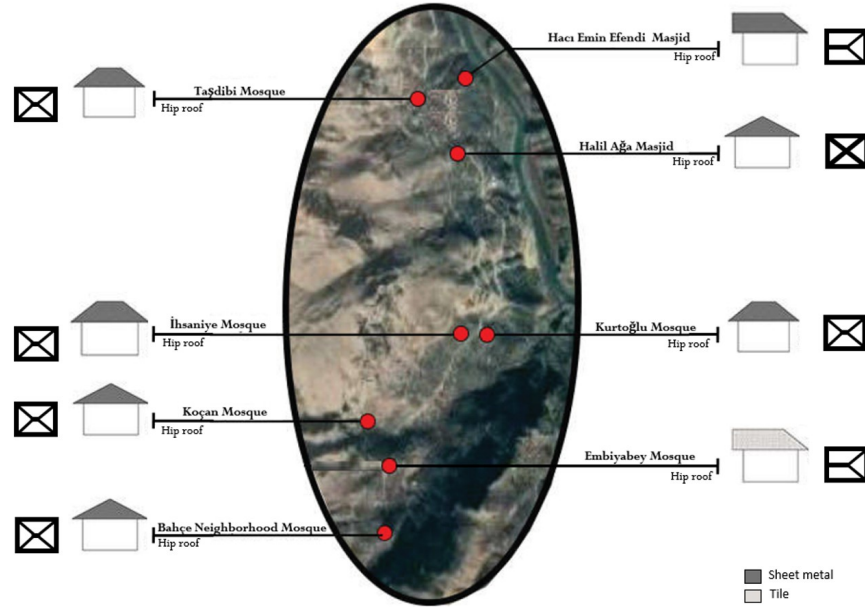
**Figure 15.** Roofing systems of the mosques (by the authors)

The current roofing systems of the structures were evaluated in terms of both material and form. Accordingly, it was determined that seven of the eight mosques (7/8; 88%) have hipped roofs covered with sheet metal, while one structure (1/8; 12%) features a hipped roof with tile covering (Figure 15).

Due to repairs and restorations carried out at different times, the original roofing systems of all registered wooden hypostyle mosques in Kemaliye's town center have not survived to the present day. However, archival research and visual documentation indicate that the original roofing systems of Taşdibi Mosque, Hacı Emin Efendi Masjid, Koçan Mosque, Embiyabey Mosque, and Bahçe Mahallesi Mosque consisted of earthen flat roofs (*soil roofs*) prior to subsequent interventions. In contrast, aerial photographs dated to 1957 indicate that Kurtoğlu Mosque originally featured a hipped roof with sheet-metal covering. On the other hand, no data were available regarding the original roofing characteristics of Halil Ağa Masjid and İhsaniye Mosque prior to the interventions.

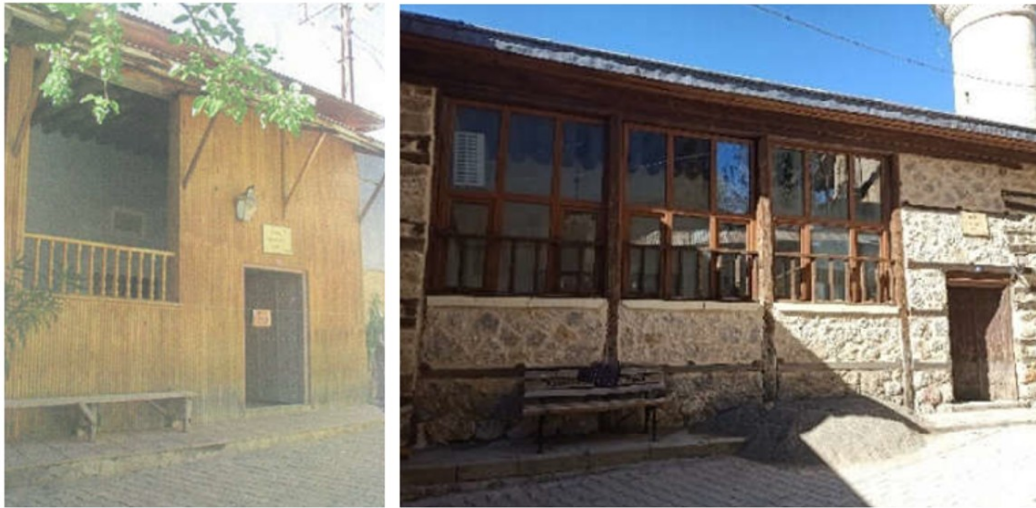
In the registered wooden hypostyle mosques in Kemaliye's town center, a diversity in the location and use of the *son cemaat mahali* is observed. Furthermore, it has been identified that, during restoration or repair processes, some originally semi-open *son cemaat mahali* spaces have been enclosed with glazing, transforming them into enclosed spaces. Bahçe Mahallesi Mosque can be cited as a representative example of this intervention (Figure 16).

**Figure 16.** *Son cemaat mahali* of Bahçe Mahallesi Mosque, originally designed as a semi-open space but later enclosed through interventions and transformed into an interior space (left, [41]; right, author's archive)

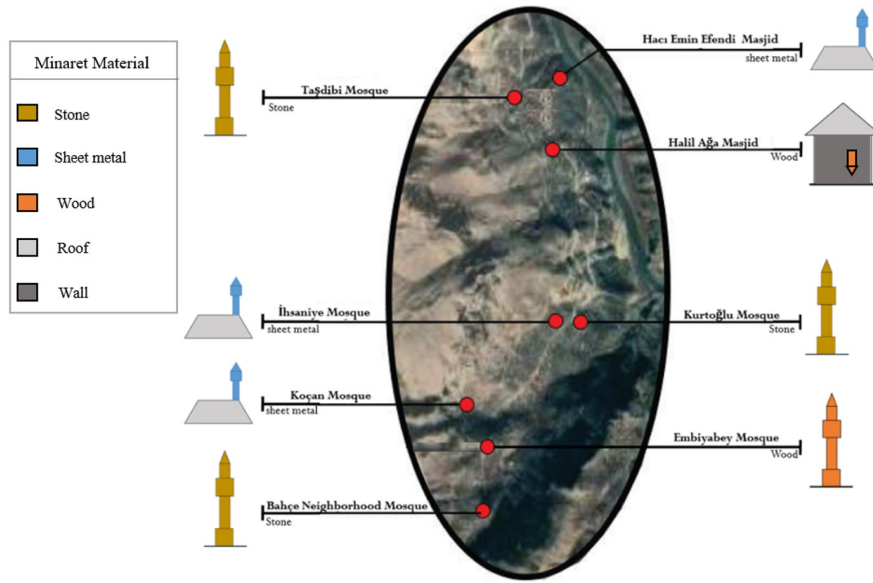
Figure 17. Minarets (by the authors)

When the current minarets are evaluated typologically, it is observed that three of the eight mosques (3/8; 38%) feature minarets rising above the roof and clad with sheet metal, while one structure (1/8; 12%) includes a wooden minaret, which has a special name *ezanlık*, positioned on the railings of the *son cemaat mahali*. In contrast, four structures (4/8; 50%) exhibit a conventional minaret composition consisting of a base, shaft, and conical cap.

Among these conventional minarets, three (3/4; 75%) are constructed of stone. Within this group, two minarets (2/4; 50%) have square-planned bases, while one (1/4; 25%) has a rectangular-planned base. The remaining structure (1/4; 25%) features a wooden minaret with a square-planned base (Figure 17).

An examination of the minarets indicates that, due to repair and restoration interventions carried out at different times, the original conditions of the minarets in all registered wooden hypostyle mosques in Kemaliye's town center have been substantially altered. Within this context, the minarets of Bahçe Mahallesi Mosque, Embiyabey Mosque, İhsaniye Mosque, Halil Ağa Masjid, and Hacı Emin Efendi Masjid are identified as non-original, while those of Taşdibi Mosque and Kurtoğlu Mosque have undergone significant interventions. No data were available regarding the original condition of the minaret of the Koçan Mosque.

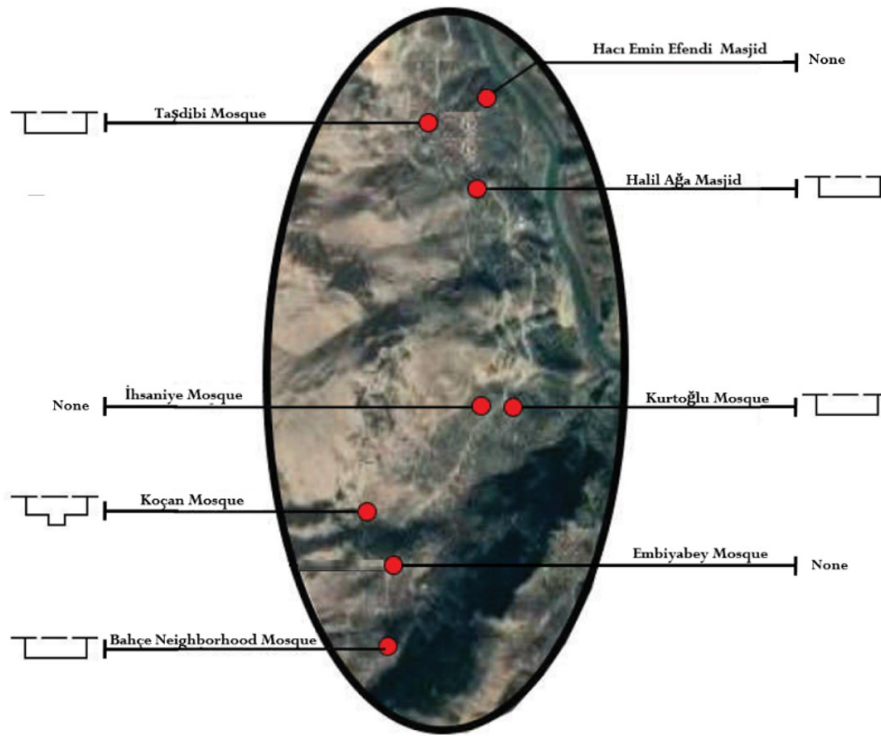
Figure 18. Plan configurations of the women's *mahfil* (by the authors)

In terms of spatial configuration, women's *mahfil* is generally arranged as enclosed gallery spaces with wooden railings. However, unlike the other examples, the women's *mahfil* in the Koçan Mosque projects into the *harim* in a rectangular form, representing a distinctive architectural scheme. An evaluation of the current conditions indicates that five of the eight registered mosques (5/8; 62%) include a women's *mahfil*, while three (3/8; 38%) do not. Among the mosques with a *mahfil*, four (4/5; 80%) do not exhibit any projection into the *harim*, whereas only one structure (1/5; 20%) features a geometrically projecting *mahfil* (Figure 18).

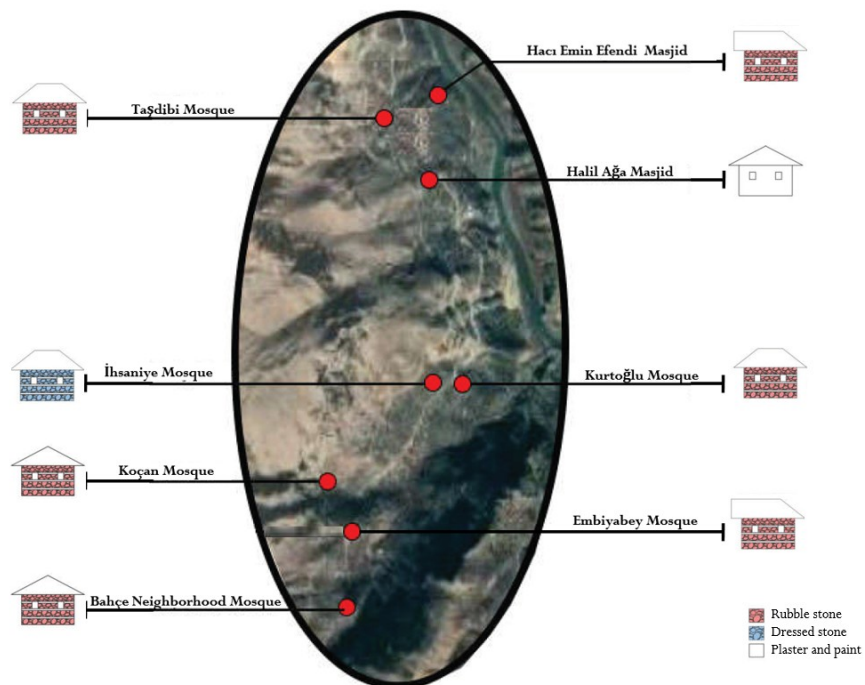
Figure 19. Wall construction materials and techniques in mosques (by the authors)

In terms of wall construction materials and techniques, the majority of the eight registered mosques examined that they used the masonry structural system. Within this context, six structures (6/8; 75%) employ rubble stone masonry reinforced with wooden tie-beams, while one structure (1/8; 12%) features dressed stone masonry reinforced with wooden tie-beams.

In addition to the primary wall materials, variations in façade treatments are observed in certain structures. In this regard, the façades of Halil Ağa Masjid, Kurtoğlu Mosque, and Embiyabey Mosque are clad with wood, whereas the façade of Koçan Mosque is clad with sheet metal. These variations reveal both the diversity of local construction practices and the impact of later interventions on the façade composition (Figure 19).

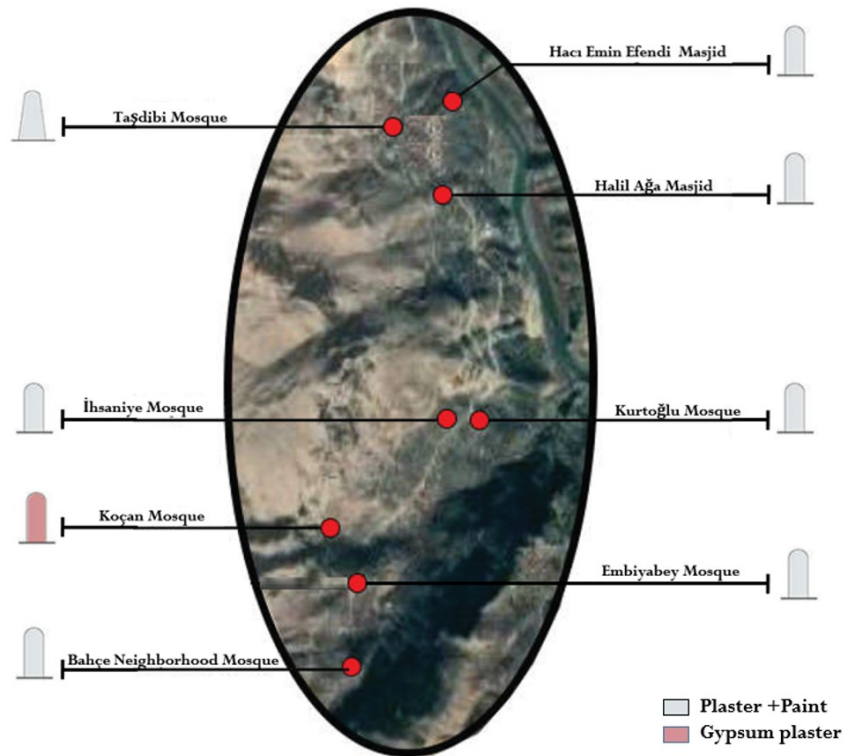
**Figure 21.** Mihrabs of the surveyed mosques (by the authors)

The examination of the *mihrabs* indicates that, in the majority of the structures (7/8; 88%), plastered and painted surfaces with semicircular forms are predominant. However, the use of stucco in the *mihrab* of Koçan Mosque distinguishes it from this general pattern. In Taşdibi Mosque, the stucco border surrounding the *mihrab*, which widens toward the base and forms a flattened semicircular profile, represents a distinctive typological variation. Conversely, due to later interventions at Halil Ağa Masjid and İhsaniye Mosque, the original semicircular form of the *mihrabs* has been obscured by decorative additions, resulting in a pointed arch at Halil Ağa Masjid and a stepped pointed arch at İhsaniye Mosque.

In terms of decoration, most *mihrabs* (7/8; 88%) (Figure 21) feature enriched surface compositions incorporating stucco borders, wooden paneling, or vegetal motifs, while the Bahçe Mahallesi Mosque lacks any decorative elements. This indicates that the *mihrab* is treated not only as a functional component but also as an element bearing aesthetic and symbolic significance. Furthermore, in some structures, *mihrabs* are located not only within the *harim* but also in the *son cemaat mahali*; such elements are also called *mihrabiye*. This reflects a degree of flexibility in use and a diversification of spatial organization in response to functional requirements.

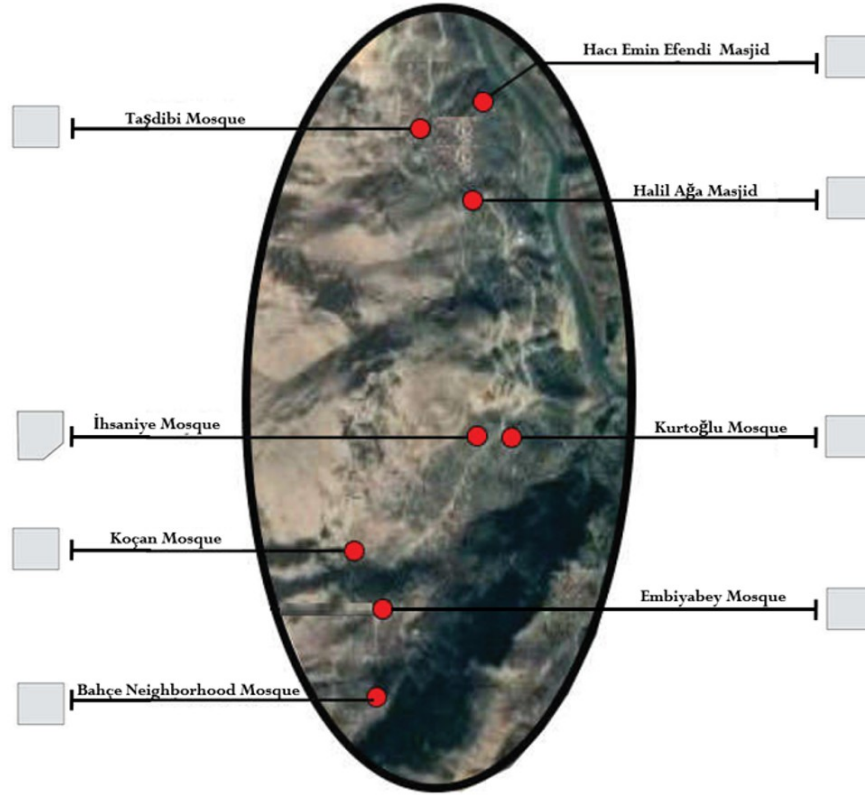
**Figure 22.** Preaching pulpits (*vaaz kürsüsü*) in the surveyed mosques (by the authors)

The examination of the *vaaz kürsüsü* (preaching pulpit) shows that rectangular, wooden, and plain (unornamented) examples are generally predominant. However, the presence of an ornamented preaching pulpit in Kurtoğlu Mosque and Koçan Mosque, the painted example in Hacı Emin Efendi Masjid, and the polygonal wooden-paneled example in İhsaniye Mosque contribute to typological diversity. The absence of a preaching pulpit in Halil Ağa Masjid is another notable variation. In general terms, four

structures (4/8; 50%) feature rectangular and unornamented examples, two (2/8; 25%) rectangular and ornamented examples, and one (1/8; 12%) a polygonal example, while one structure (1/8; 12%) does not include this element (Figure 22).

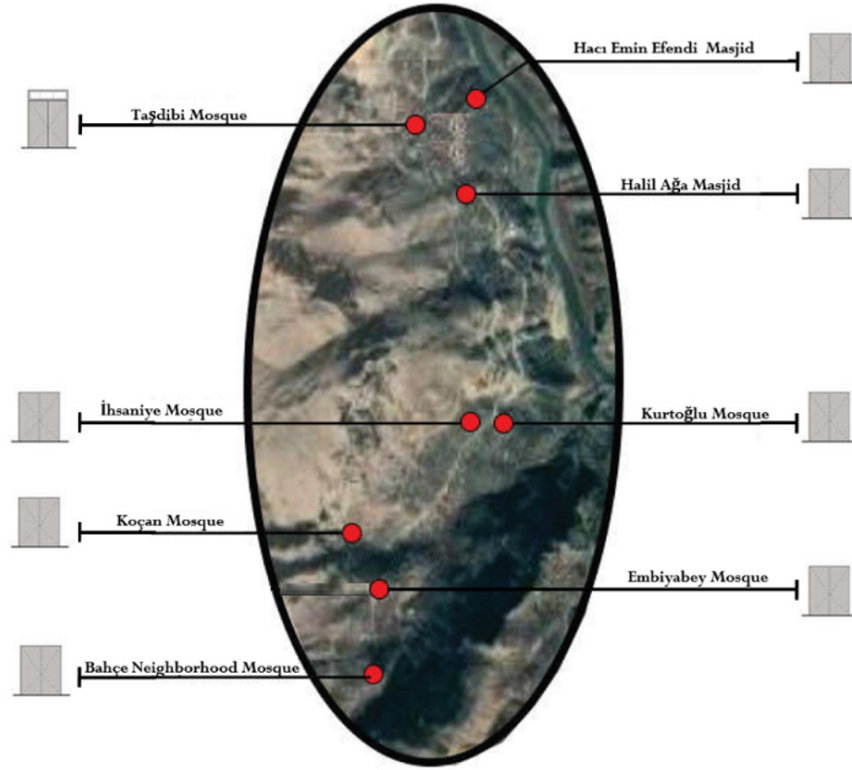
**Figure 23.** Doors of the surveyed mosques (by the authors)

Door and window openings constitute the primary components of the façade composition in the registered wooden hypostyle mosques in Kemaliye's town center and play a decisive role in interpreting their typological character. Entrance door openings to the *harim* are rectangular in all examples, and the doors are designed as double-leaf wooden doors. This indicates a clear typological continuity within the building group. In Taşdibi Mosque, the presence of a fixed window above the door opening represents a distinctive feature that diverges from this general scheme. Additionally, iron door knockers positioned on the doors stand out as a traditional local element specific to Kemaliye, reflecting the integration of vernacular features into mosque architecture. In contrast, the absence of such knockers in İhsaniye Mosque constitutes an exception to the prevailing pattern (Figure 23).
